SOUTHEAST ASIA INTRUDERS (2)

USN A-6A, A-6B, & KA-6D Intruders in the Vietnam War

Includes
Full Airframe
Data/Stencils
Sheet 72-011

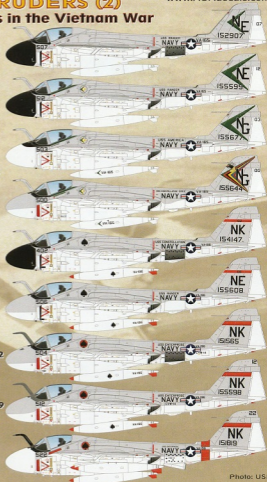
(R) - ALSO APPLY TO OPPOSITE SIDE

* SEE NOTES

24 - AN/ALR-15 equipped aircraft only

73 - WALKWAY markings (and border striping) not always standard.

125 - TACAN equipped aircraft only.

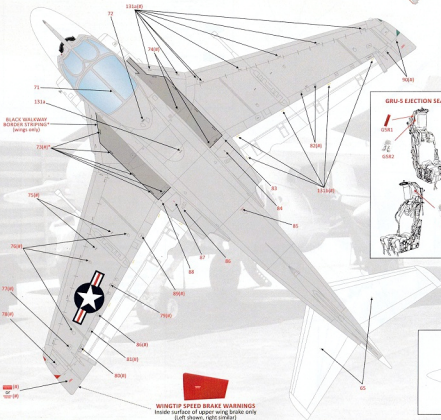
KA-6D

BLACK WALKWAY
BORDER STRIPING*
(wings only)

NOSE LANDING GEAR

MAIN LANDING GEAR
(left gear shown, right similar)

EXTERNAL FUEL TANK

WINGTIP SPEED BRAKE WARNINGS
Inside surface of upper wing brake only
(left shown, right similar)

Fuselage markings are not shown in overhead views.
 Refer to scheme information descriptions for specific airframe details and antenna configuration.
 Note the location of the national insignia on the underside of the wing varied.

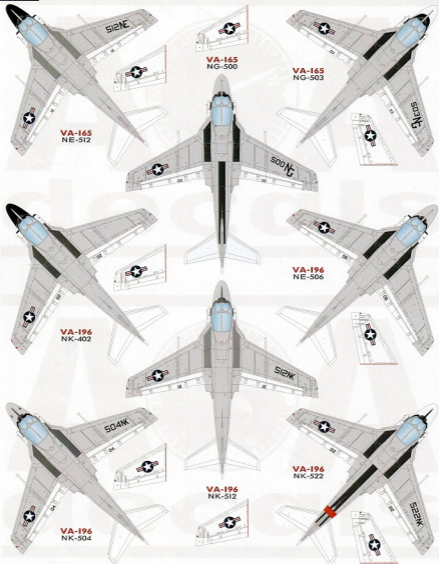
72-013 The profile illustrations attempt to depict the applicable markings, antennas, and airframe configurations for each specific aircraft. Also refer to the other instruction pages for overhead views, configuration details, and insert sheet for additional scheme information.
