Aviaology Venturas in Canada 2

Ventura GR.V
enigma U-bat aircraft
113 (BR) Sqn, 1944 - 1945?

113 & 145 (BR) Squadrons, Eastern Air Command, RCAF

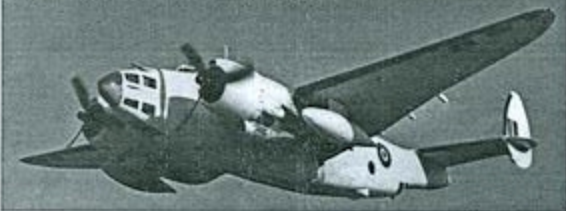
One of the 17 to 20 early-nosed Venturas in RCAF service featuring a Ubat (U-boat battle) marking. From Carl Vincent's notes: "113(BR) was the first RCAF unit to receive the GR.V; it operated some of the Hudsons that preceded the Venturas in an all-white paint scheme without codes and serials; it did carry prominent Ubat markings when appropriate; and did, on at least one occasion, carry out an attack with a Ventura on a suspected U-Boat. Therefore the probability that the photo depicts this or a similar aircraft is, though without proof, at the least a tenable hypothesis."

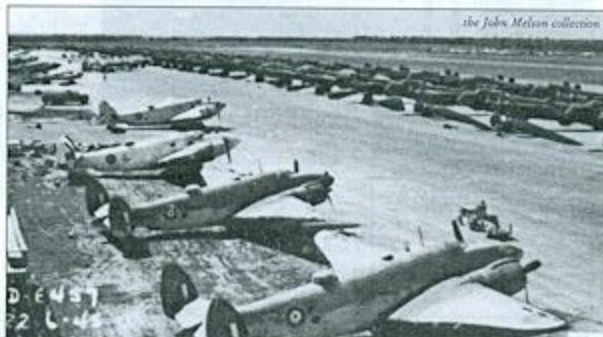
Before: A factory fresh Ventura c/n 5091, still in the Vega applied markings soon after arriving in Canada. EAC appears to have preferred operating these aircraft without hubcaps - at least initially.

After: Now as RCAF Ventura 2141 and aircraft "C" of 145 (BR) Sqn. The photo was taken at Scoudouc, NB on 22 June 1945 which makes the early style national insignia seem very out of place. However, it seems very likely that the two Venturas in the foreground, including 2141, were in stored reserve and pulled out for some occasion, along with the more "properly" marked Venturas beyond. Note the rows of Tiger Force Lancasters in outdoor storage.

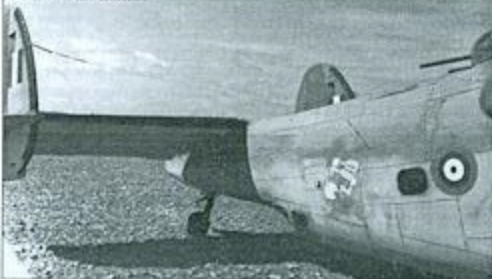
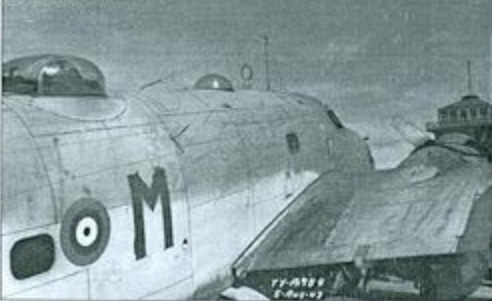
These two excellent photos of Ventura 2146's more arsy side, reveal a wealth of detail. The Non Specular (the original USN specification for dead flat) paintwork appears to have weathered some, but remains in good condition. The colours used to overpaint the factory-applied US cockades seem a very close match for the original camo colours (compare with 2141 on pg. 3), and the USN BuNo marking is still visible on the fin and rudder. The miniature rounded and fin flash were common on EAC Bomber Reconnaissance types for a time. The author submits that this combination was the second variation of national markings used on the command's GR.Vs and other ASW types. This aircraft features the rarely seen "low shang" main aerial rig, with the wire strung along two small stand-offs along the fuselage sides. Note also, the worn walkway section.

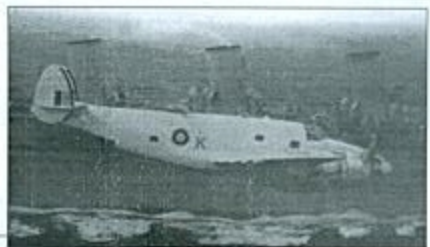
One of the earliest arrivals, Ventura 2152 was formally accepted by the USN on 6 March 1943, delivered two days later, and promptly transferred to Canada on the last day of the month, and initially in service with 113 (BR) in the delivery scheme as aircraft "N". From Carl Vincent's original caption: "Eastern Air Command, including 145 (BR) continued to work non-stop til VE Day and beyond. Here Ventura 2152 flies very close escort to the troopship *RMS Aquatania*, the last of the magnificent four-stack ocean liners. The forward (and fourth) funnel is out of sight to the right of the photo." Although the original photo is somewhat grainy, there is evidence that the aircraft's late 1943 - early 1944 era paintwork is giving in to wear and tear - especially around the engine cowls and nacelles, and the area of the rear fuselage just ahead of the serial number. The serial itself has been reapplied in smaller than specification characters. It may be that 2152, like the aircraft at the top of pg. 3, also operated without identity markings for a time before the serial was reapplied.

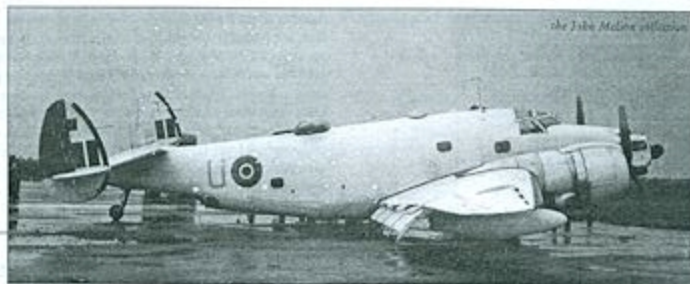
Ventura GR.V 2156, 113 (BR) Sqn

most probably a prior repair that had yet to be refinished in White.

These two photos, taken at the time of a Cat B incident at Torbay, Newfoundland, while 2156 was with 113 (BR) on 26 August 1944, this illustration shows another variation of the overall white ASW scheme used on EAC Ventura GR.V's. In this case, the fuselage rounded and code letter are differently positioned (similar to the earlier markings on 2141, see item 18a) when compared to those on 2152 above, and the starboard rudder appears to have had repair work done. The accident - a crash-landing - resulted in the aircraft being written off, and formally SCOS 6 November 1944. The close-up photo shows the rear of the ASD radar scanner, as well as the serial "last two" on the mangled nose undersurface. Unusually for an RCAF accident victim, the nose guns have remained installed on the trip back to the hangar.

8 both tails, both surfaces, w/ red forward. Usually allowed to not interfere with de-icer boot.

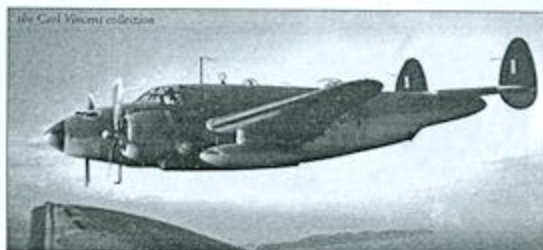
This aircraft was photographed, in flight, in the illustrated finish and markings during the summer of 1943 when with 145 Squadron at Torbay, Newfoundland. According to USN records, BuNo 33148 was transferred to Canada on 19 March 1943 and stricken from their "books" on 7 April (presumably the ferry flight date?). By 30 April she was on 145 (BR) Squadron strength as "P". Ventura 2159 was struck off RCAF strength on 7 December 1946 and probably received the overall white scheme at some point in what was, by all accounts an uneventful operational career.

The colour demarcation on the radome nose cap interior does not match exactly that on the fuselage exterior. Note also, the obvious spot refinishing to overpaint the US cockade on the upper wing surface of the wing of the camera aircraft. The small EAC style wing roundel is just visible further outboard.

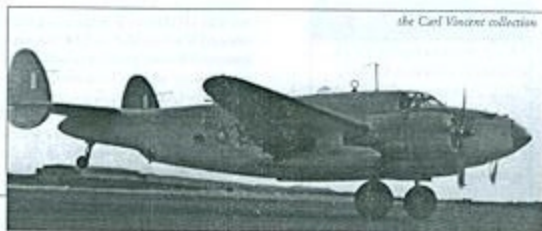
Another of the 7 April deliveries, BuNo 33160 became a "paper" transfer to Canada one day earlier than, but formally accepted by the USN from the factory on the same day as BuNo 33148 (see 2159, pg. 5). As RCAF Ventura 2160, this aircraft also entered 145 (BR) Squadron service on the same day as 2159 but was SOS on 19 March 1944 (exactly one year plus a day after its USN transfer) at Gander - cause unknown. Together, these profiles show the typical EAC finish and markings of the period - the USN two-colour scheme with the USN cockades neatly overpainted in "close match" local colours, small 20 or 22 inch RCAF fuselage roundels and Ventura-specific fin flashes. The serial and nose repeat of the aircraft letter are a nominal 8" high, although the serial characters on 2160 appear wider than spec. Also note the larger, differently styled code letter, and what appears to be an incorrectly painted nose cap, on this aircraft.

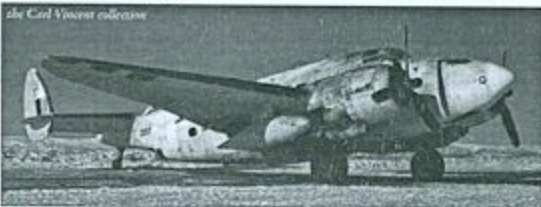
Photographed on 17 February 1945, a grimy Ventura 2207 was among the aircraft that had taken shelter from a blizzard at RCAF Summerside, PEI. The fuselage is obscured by the wing in the photo, so the code letter illustrated above, if carried in this instance, is modelled on that shown for Ventura 2152 / K. This Ventura was transferred 16 April 1943, and TOC 25 June 1943. SOS 22 January 1947.

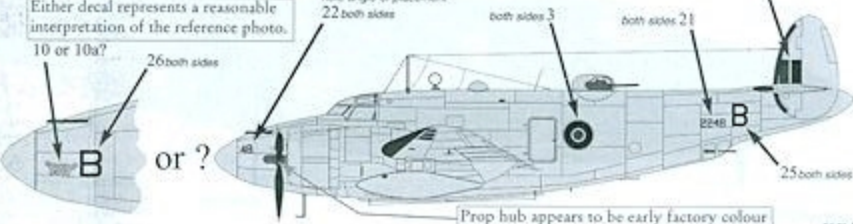
This Ventura was TOC 18 September 1943 in EAC and is reported to have served with 113 (BR) as "B" - probably until the unit disbanded 23 August 1944. A number of 113 (BR) Venturas, including 2235 "A" (c/n 5382) and this aircraft, ended up with EAC's ambiguously named Operational Training Squadron (OTS), which was established at Pennfield Ridge soon after the disbanding of 34 OTU on 19 May 1944. OTS GR.Vs appear to have been pressed into the training regime "as is", with only a minimum of changes in finish and markings made (at least initially) by local maintenance personnel. One photo in the Pennfield Ridge collection showing the nickname "PAT" adorning 2248's nose to port. This is most probably from her 113 (BR) days and remained when she first joined the OTS inventory. However, within 1945 (Course 11) it had been removed in favour of a simple serial last-two repeat.

Prop hub appears to be early factory colour
