S 31 Spitfire PR. Mk. XIX

Spitfire S 31, PR. Mk. XIX Painting and marking information

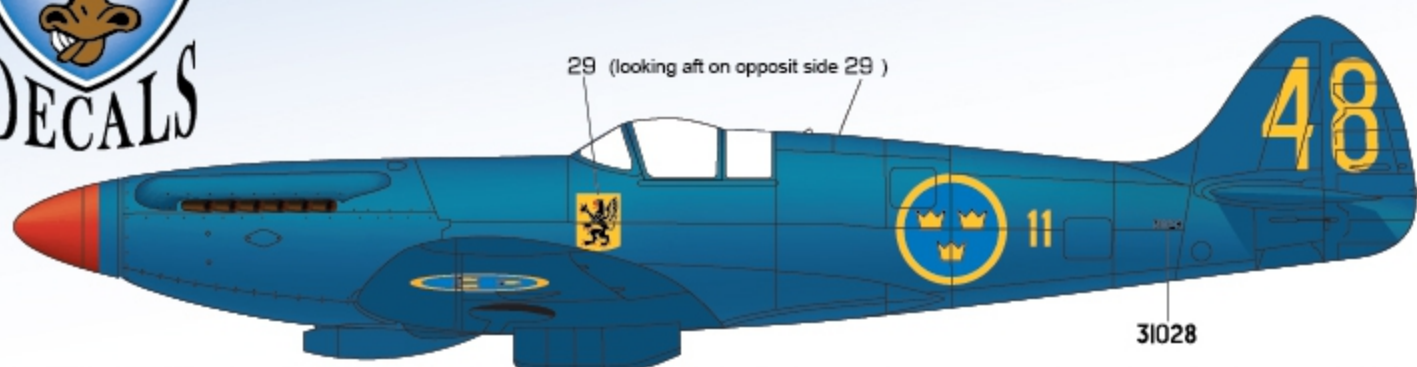
S 31, 31028, 48 - F11. Markings from 1949 when the first squadron was stationed at Karlstad airfield to provide forward air control and artillery spotting for a couple of weeks during summer exercises. Short walkways.

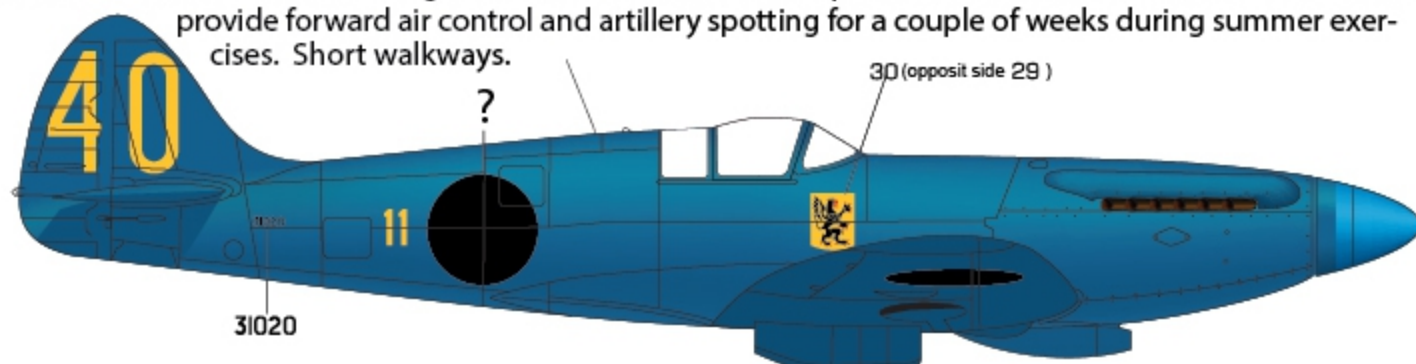
S 31, 31020, 40 - F11. In this aircraft, the commander of second squadron F11, Ingemar Wängström, flew a photo reconnaissance mission over Murmansk on the 25th September 1949. According to intelligence from Soviet defectors, the Soviet Union were building rocket launch ramps in the area. The pictures from the mission showed that this was not the case, however. The idea of covering the national insignia with black paint in order to avoid identification and conflict with the Soviet's was thought to be Wängström's idea. On the other hand, the mechanic that was assigned on the mission cannot remember these black markings. The mission was one among many that the Swedish Air Force (in co-operation with the Swedish Intelligence Service) made in the years between 1949 and 1953. Other popular targets were the ship yards along the Baltic and Polish coasts (almost on a weekly basis) - these missions were made without covered national insignia, however. It is not clear to which squadron this aircraft (a/c) was assigned, hence, the spinner colour is somewhat uncertain. It is likely that the a/c was taken from Wängström's own squadron - second - and at this time it was standard to paint a larger part of the spinners in squadron colour but no white stripe.

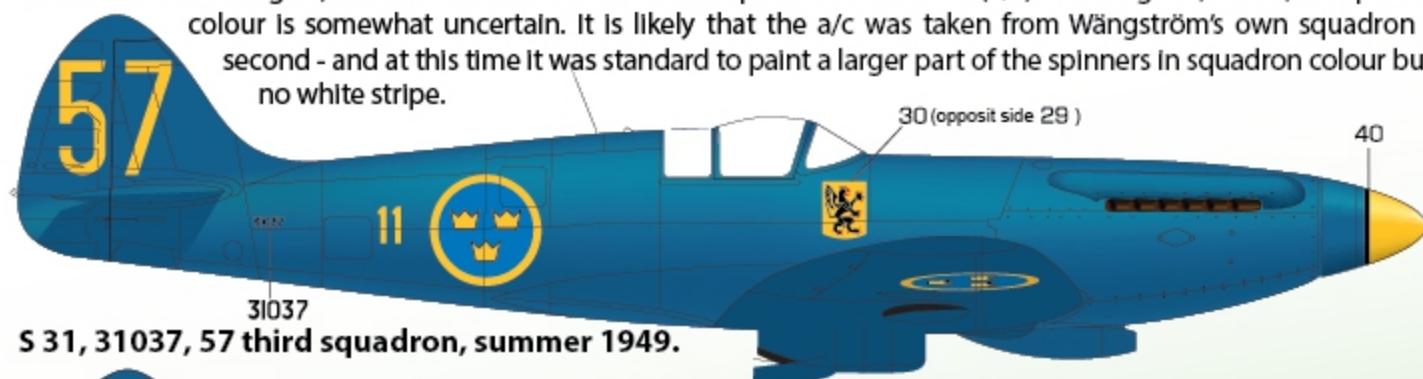
S 31, 31037, 57 third squadron, summer 1949.

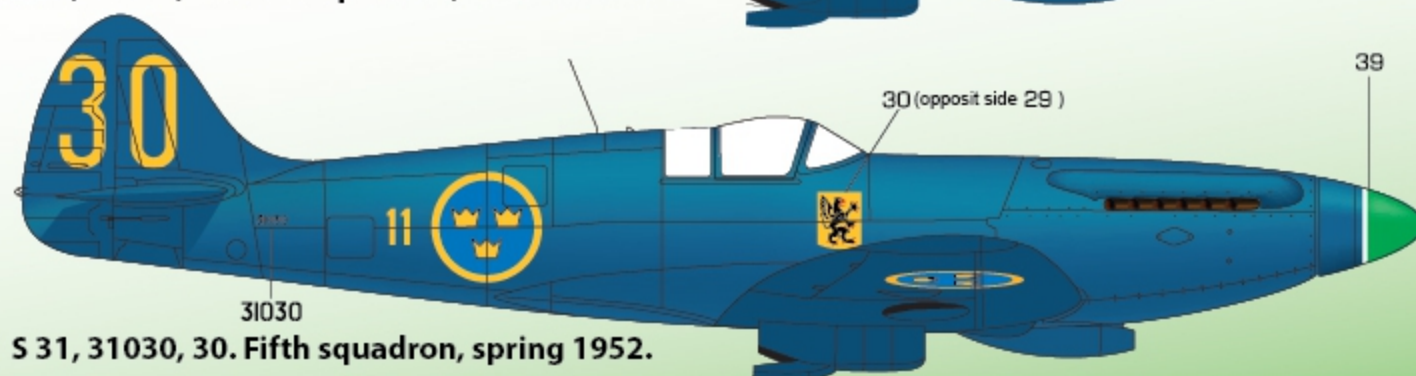
S 31, 31030, 30. Fifth squadron, spring 1952.

Probably painted sheet metal cover instead of clear aft section thus to crack problems in this part towards the end of the service time.

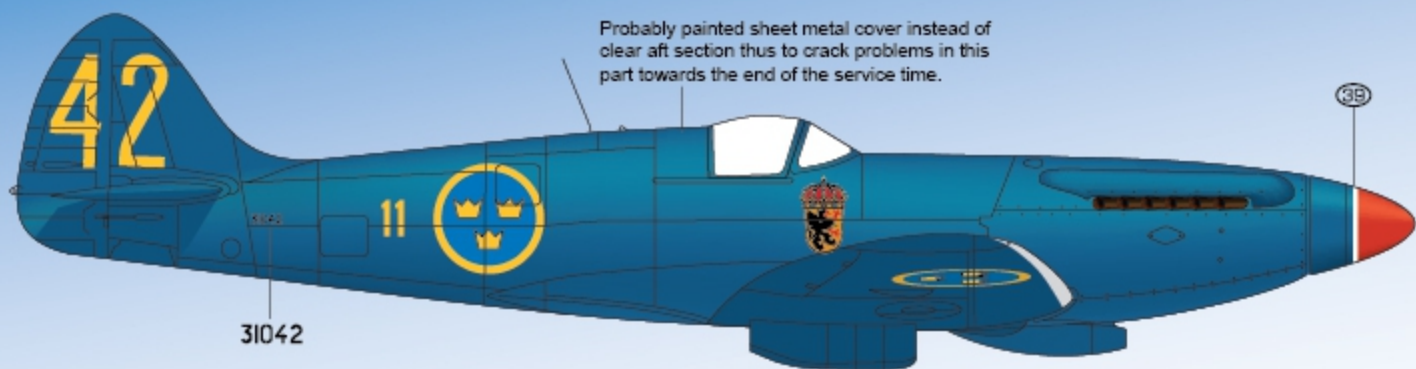
31042

S 31, 31042, 42 - F11. During the last years, the Spitfires got the later, more elaborate Coat of arms with gold as later used on the Vampires and Tunnans. The markings are according to the time of an accident when the a/c crashed into an S 14 Fieseler Storch. Pointed blade type, drawing number 10130, decals (24a) and use four decals (51c) plus (51a) or (51b) on the master blade. No Rotol logotype on blades.

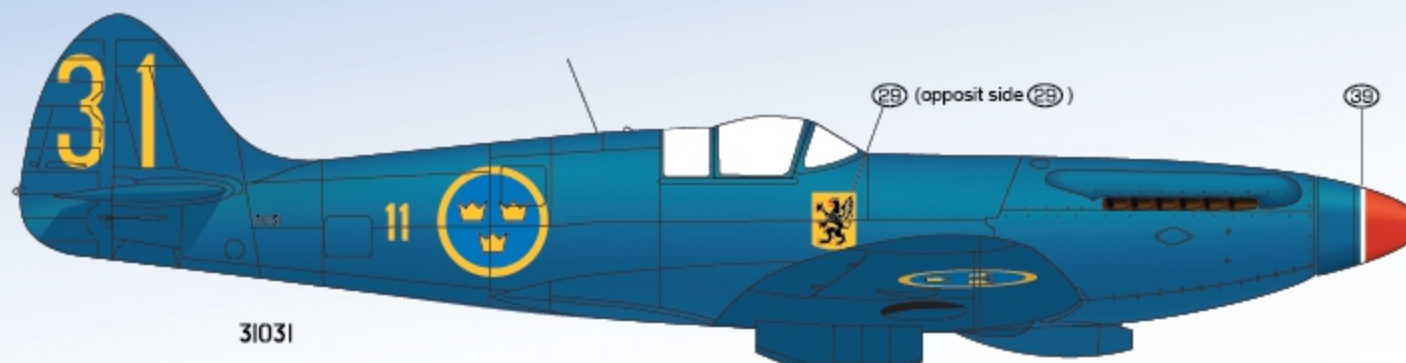
31031

S 31, 31031, 31 - F11 Skavsta. Markings from the 9 of May 1951, when it crashed at F17 airfield and broke the starboard landing gear, cooler and the propeller. Markings are according to pictures and the pilot Schyllström himself. The propeller blades were not marked with Rotol logotype at this time. On the 15th of June 1953, this a/c was flown by Bengt Palmqvist who made the only parachute jump from a Swedish Spitfire. According to his partner, the a/c was freshly painted and had a blue spinner at the time. Later investigation concluded that the engine broke due to a broken bearing and piston rod.

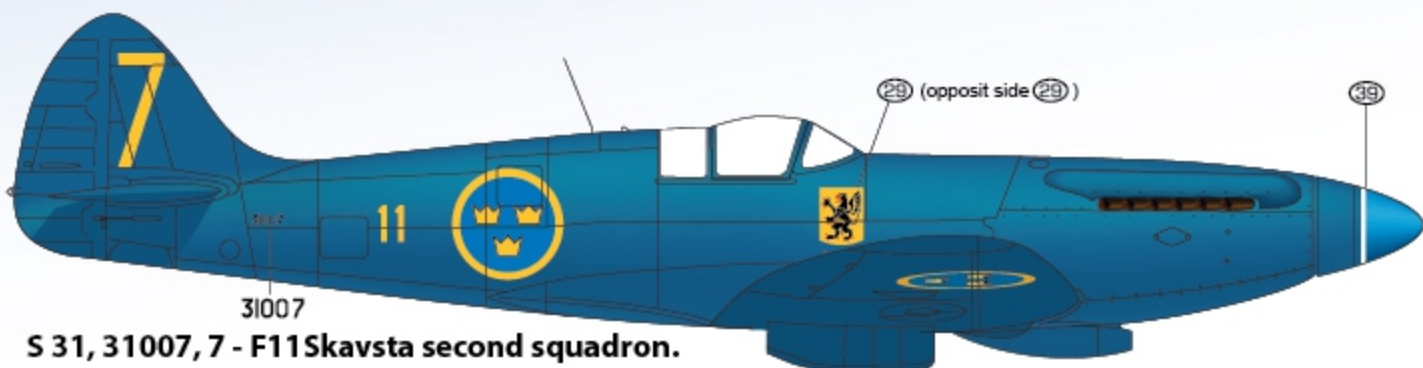
31007

S 31, 31007, 7 - F11 Skavsta second squadron.

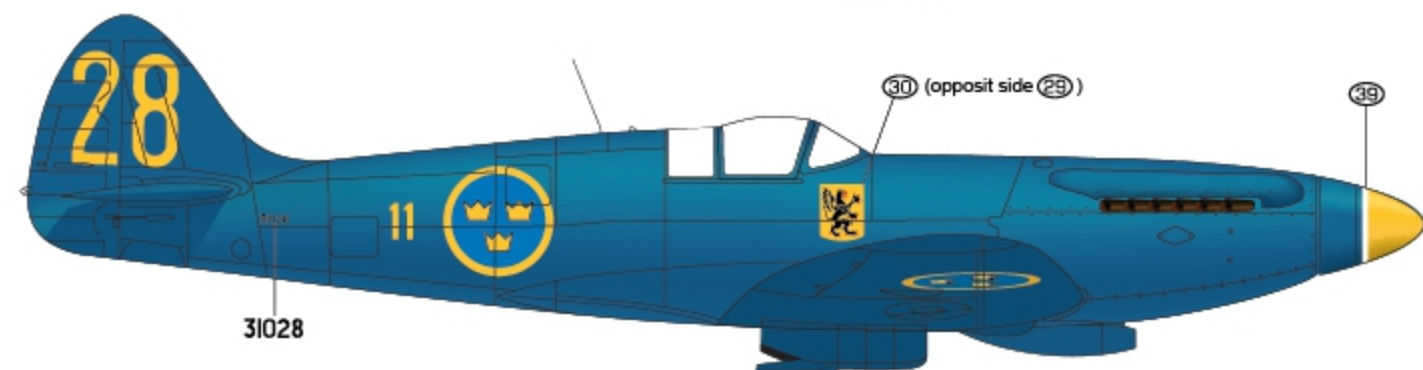
31028

S 31, 31028, 28 - F11 Skavsta third squadron Februray 1952.

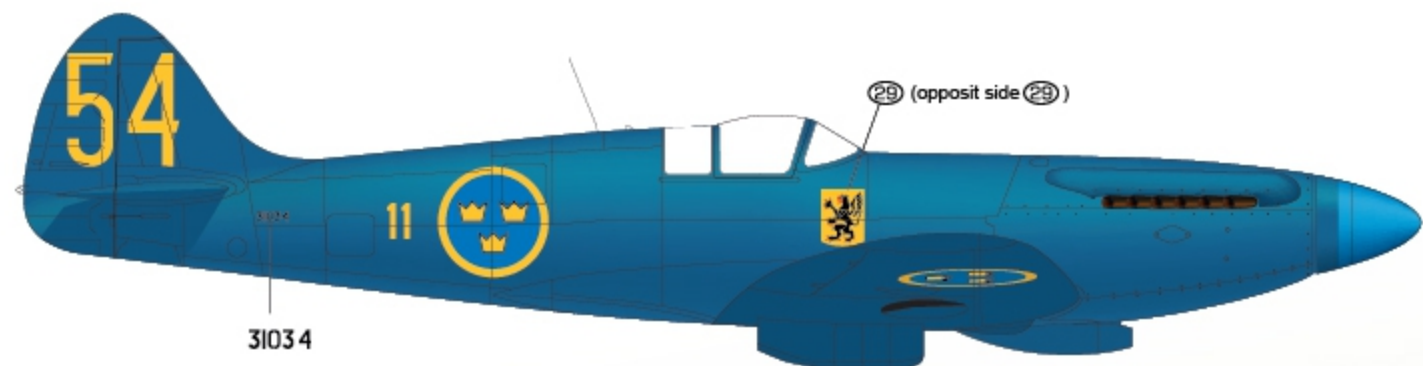
31034

S 31, 31034, 54 - F11 Skavsta, summer of 1949. The spinner was probably insignia blue, but this is very hard to distinguish from PRU blue. Pictures show this aircraft with a white fabric band around the empennage, this was used in order to secure the tail to the ground during full throttle runs on ground.

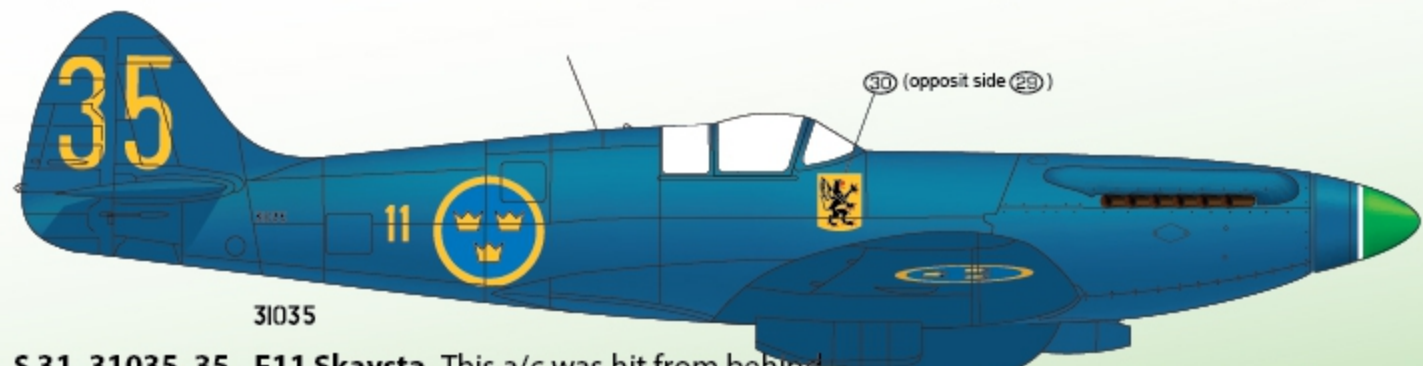
31035

S 31, 31035, 35 - F11 Skavsta. This a/c was hit from behind on the 19 of May 1952 when 31034 taxied up in the tail of 35. This a/c was equipped with belly tank at this date

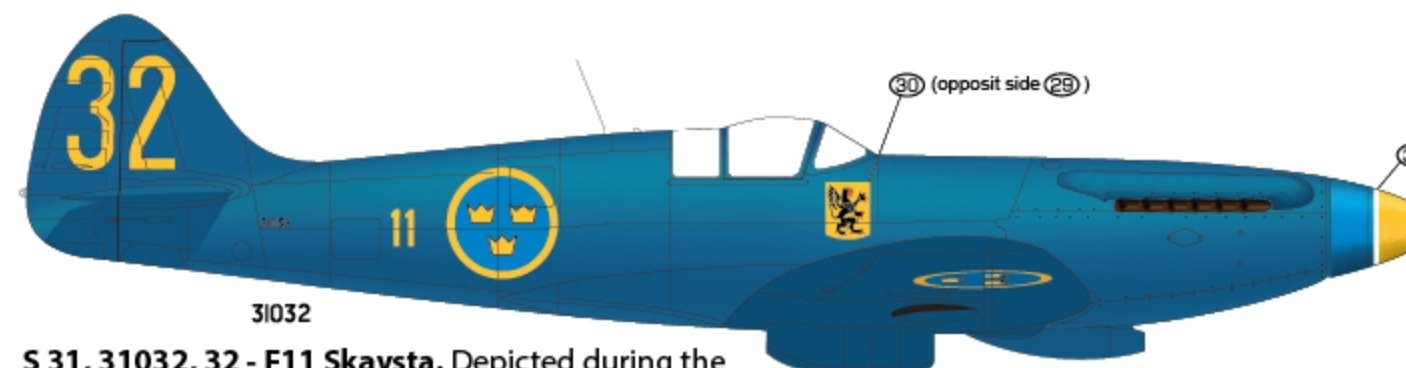
31032

S 31, 31032, 32 - F11 Skavsta. Depicted during the summer of 1953. The spinner looks a bit strange in pictures, the inner part is much brighter than the PRU blue fuselage, it may be insignia blue but for some strange reason it may also be some other colour (green?!). This a/c had short walkways and less pointed blade type, 10378RTS, use decal (24b). Also, use 5 x decal (26) on the spinner. No Rotol logotype on blades .
